Subject:
Letter Report
Removal of Underground Diesel Piping System at GE San Germán Facility
Case 16-196

This letter report summarizes the activities conducted by Arcadis from January 31, 2017 through April 12, 2017 related to the removal of the 375 lineal feet

underground diesel piping system as authorized by PRIDCO in their Work Plan Approval Letter dated January 4, 2017.

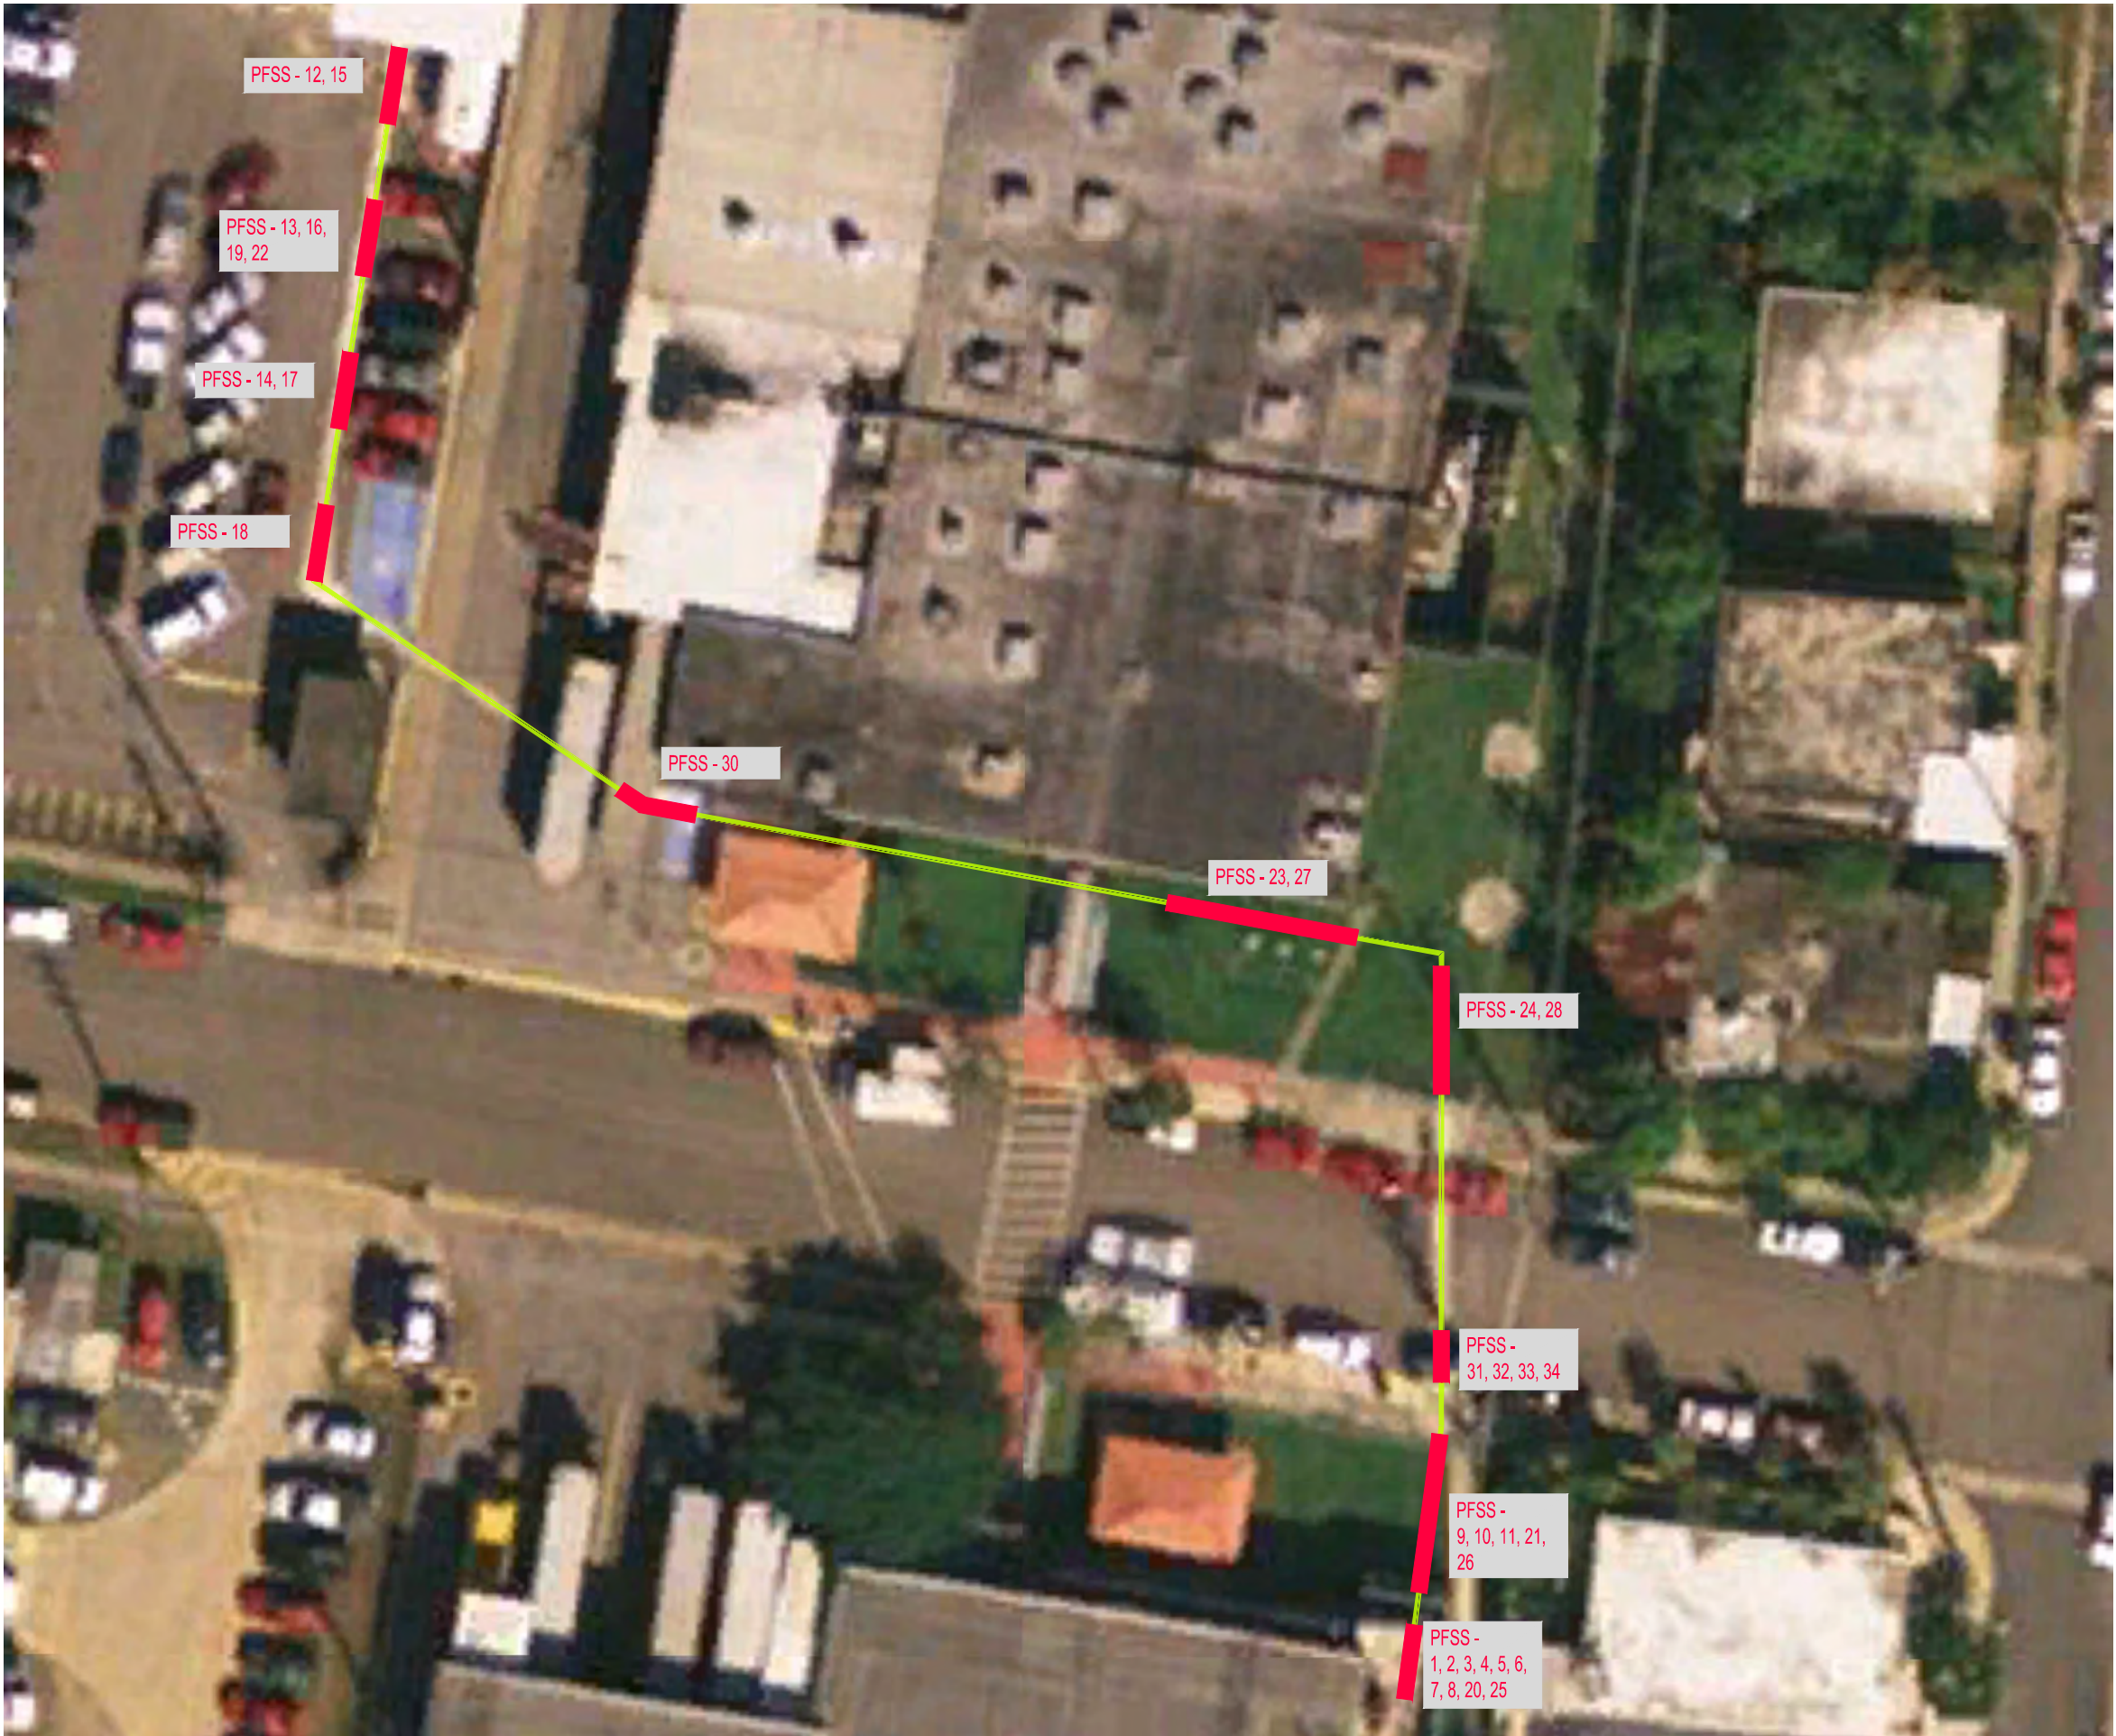
FIGURE 1

Soil Screening Map

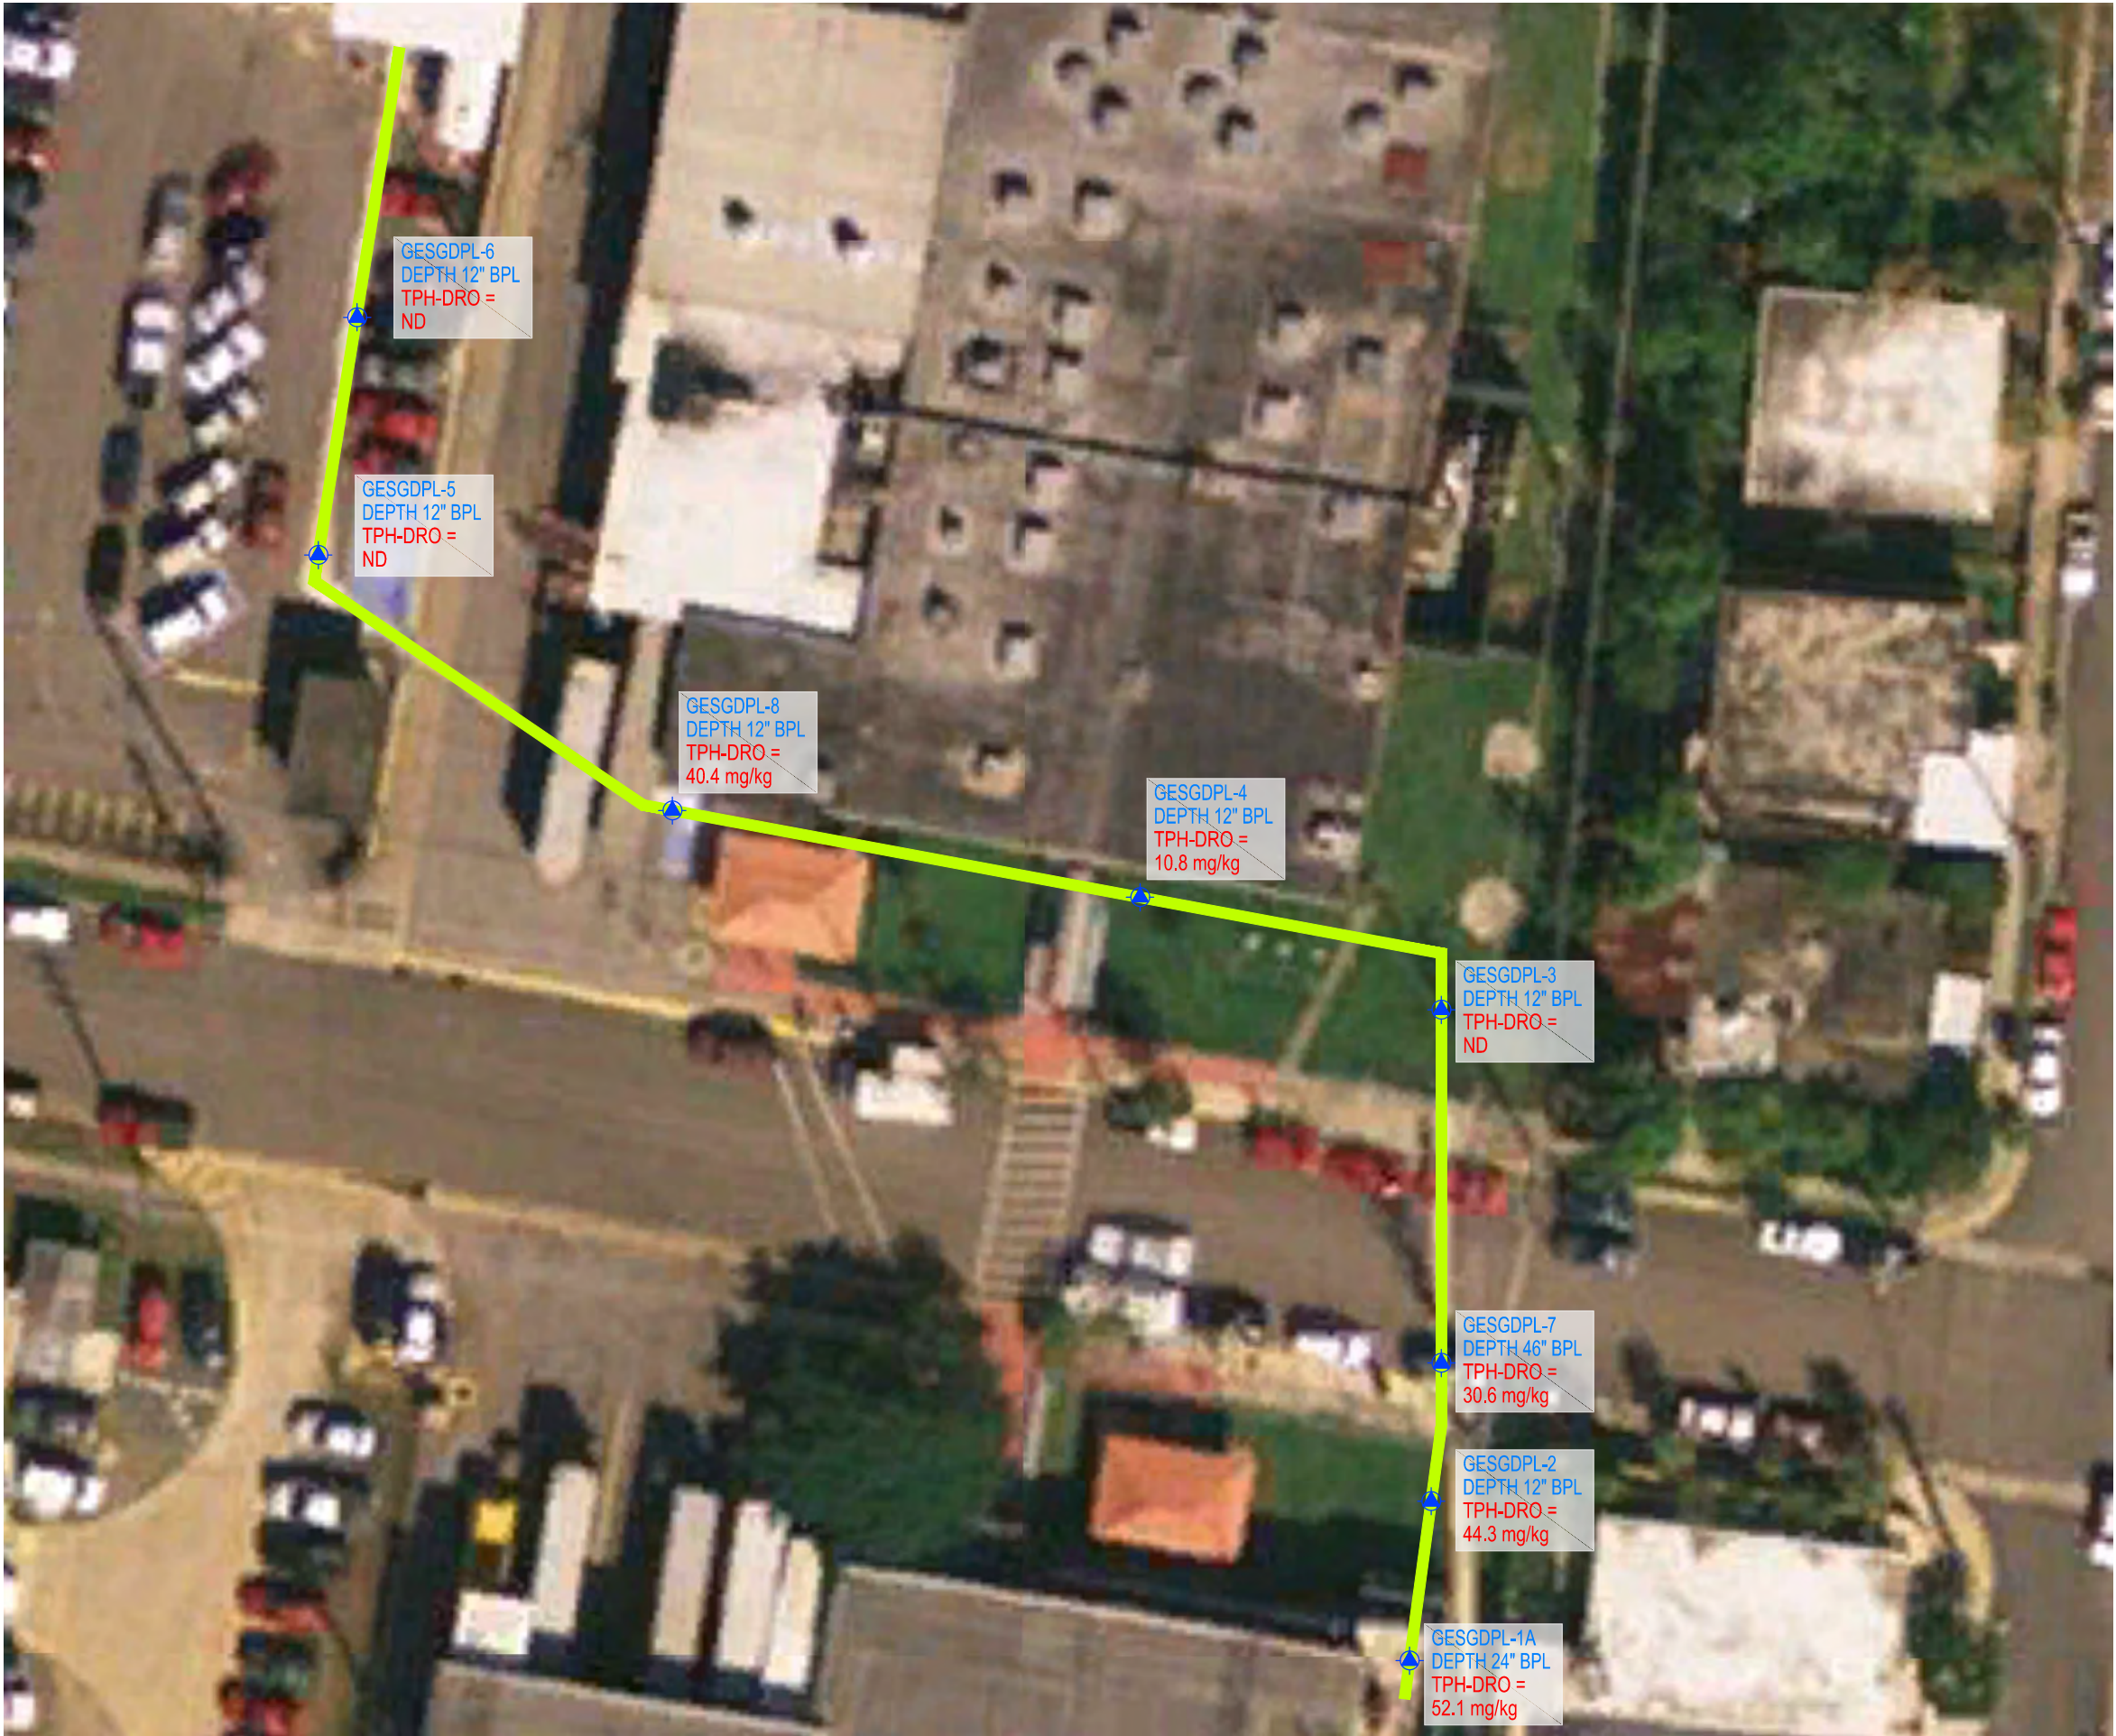
FIGURE 2

Soil Quality Map

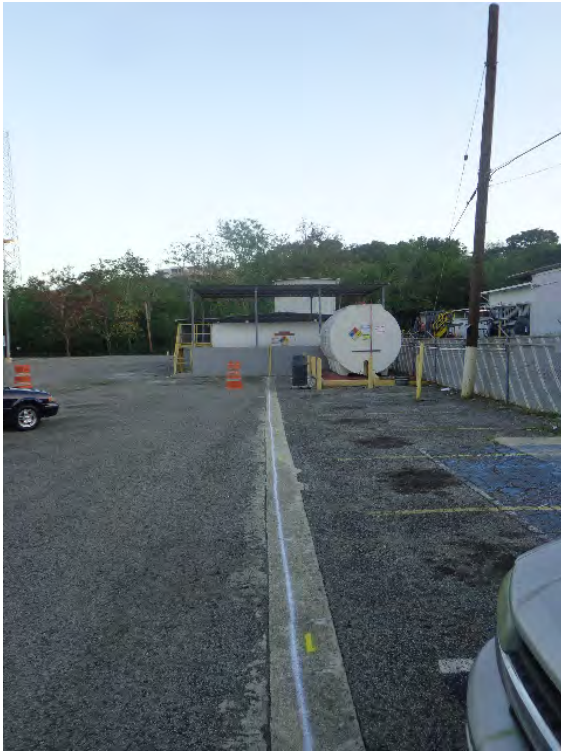
Photograph: 1

Description: View of underground diesel pipeline location (white line) as required by the Excavation Center of PR DTOP prior removal activities.

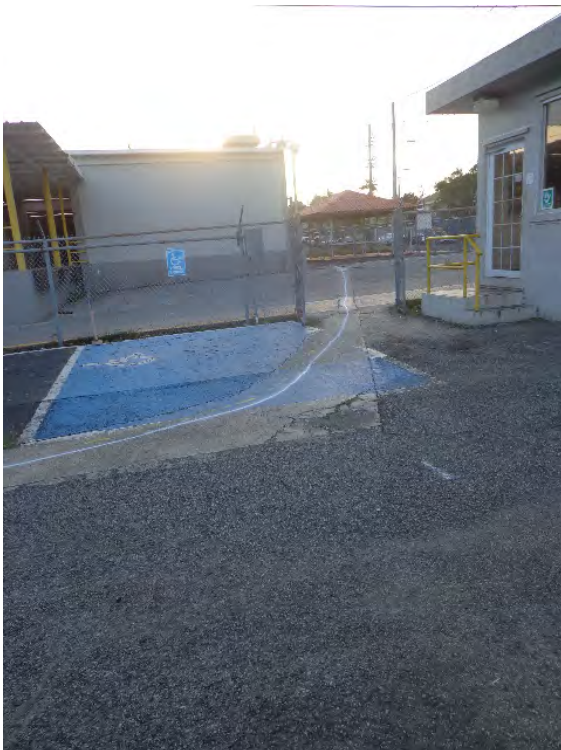
Photograph: 2

Description: View of underground diesel pipeline location (white line) as required by the Excavation Center of PR DTOP prior removal activities.

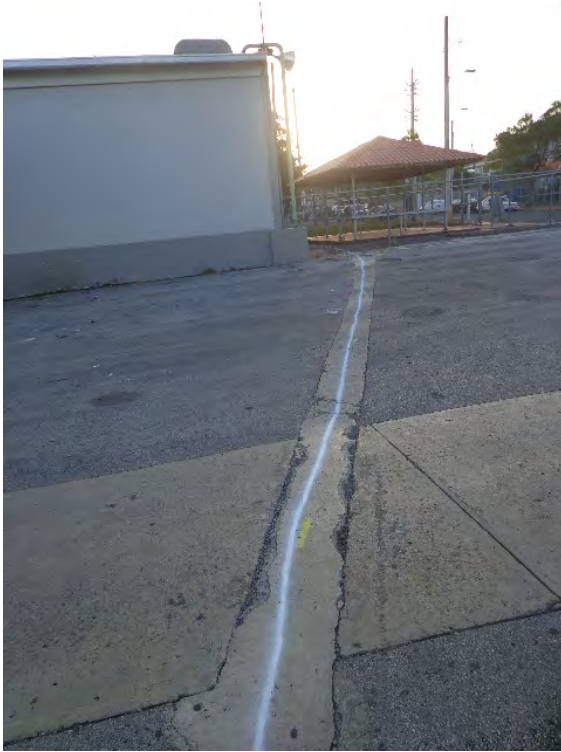
Photograph: 3

Description: View of underground diesel pipeline location (white line) as required by the Excavation Center of PR DTOP prior removal activities.

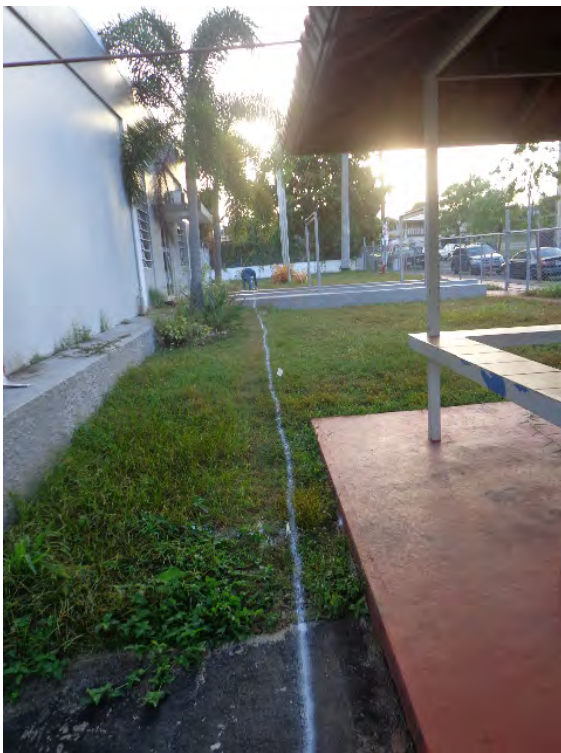
Photograph: 4

Description: View of underground diesel pipeline location (white line) as required by the Excavation Center of PR DTOP prior removal activities.

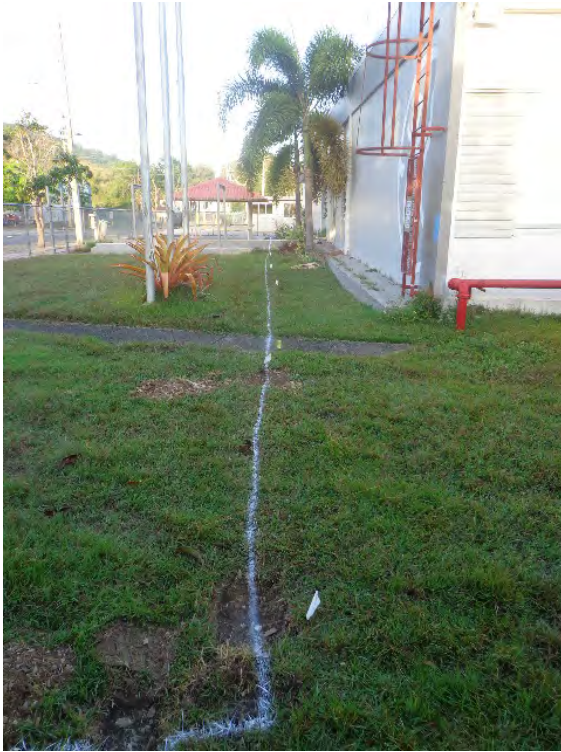
Photograph: 5

Description: View of underground diesel pipeline location (white line) as required by the Excavation Center of PR DTOP prior removal activities.

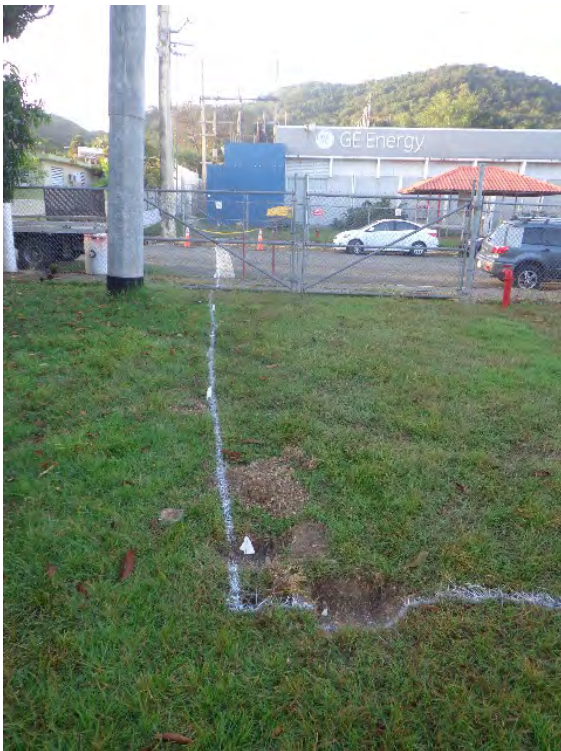
Photograph: 6

Description: View of underground diesel pipeline location (white line) as required by the Excavation Center of PR DTOP prior removal activities.

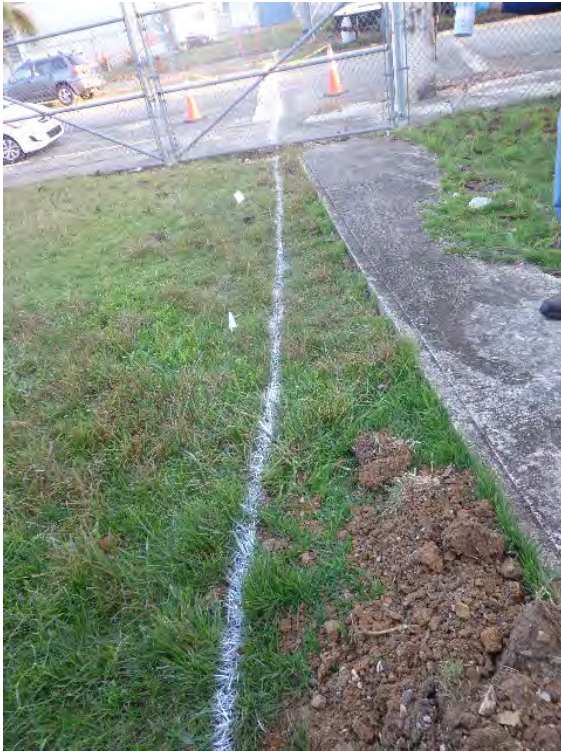
Photograph: 7

Description: View of underground diesel pipeline location (white line) as required by the Excavation Center of PR DTOP prior removal activities.

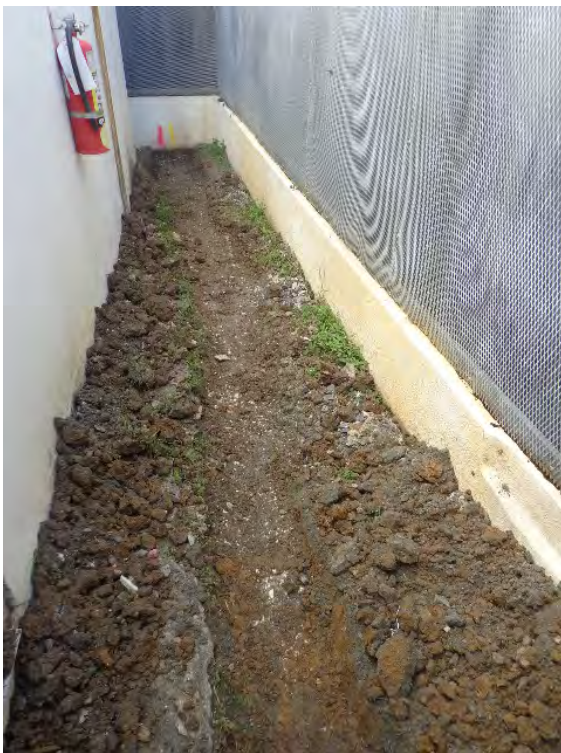
Photograph: 8

Description: View of underground diesel pipeline location (white line) as required by the Excavation Center of PR DTOP prior removal activities.

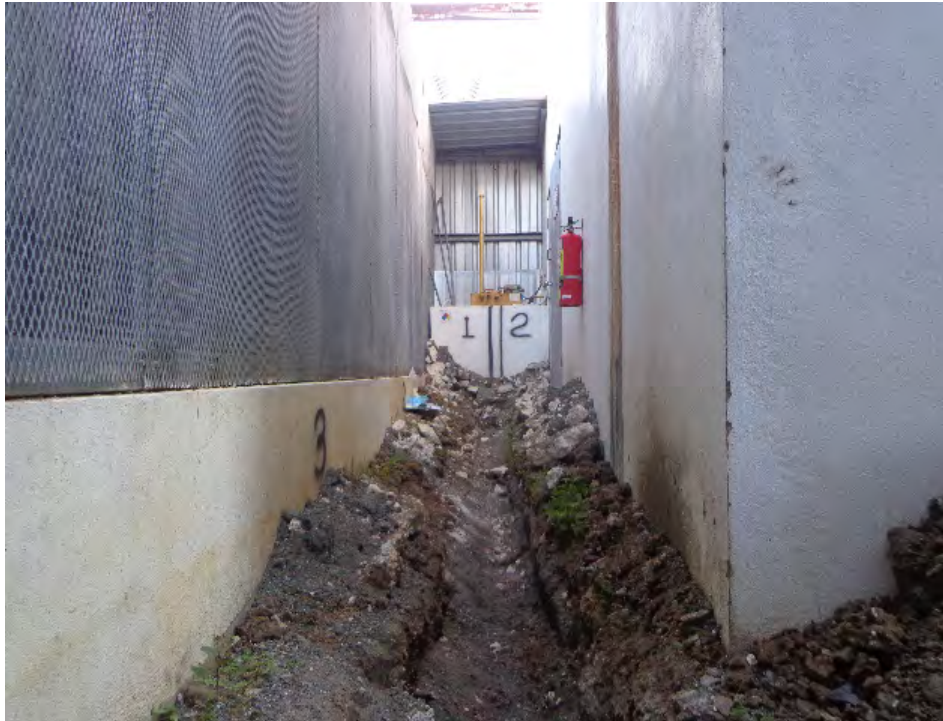
Photograph: 9

Description: Removal of top soil to located pipelines.

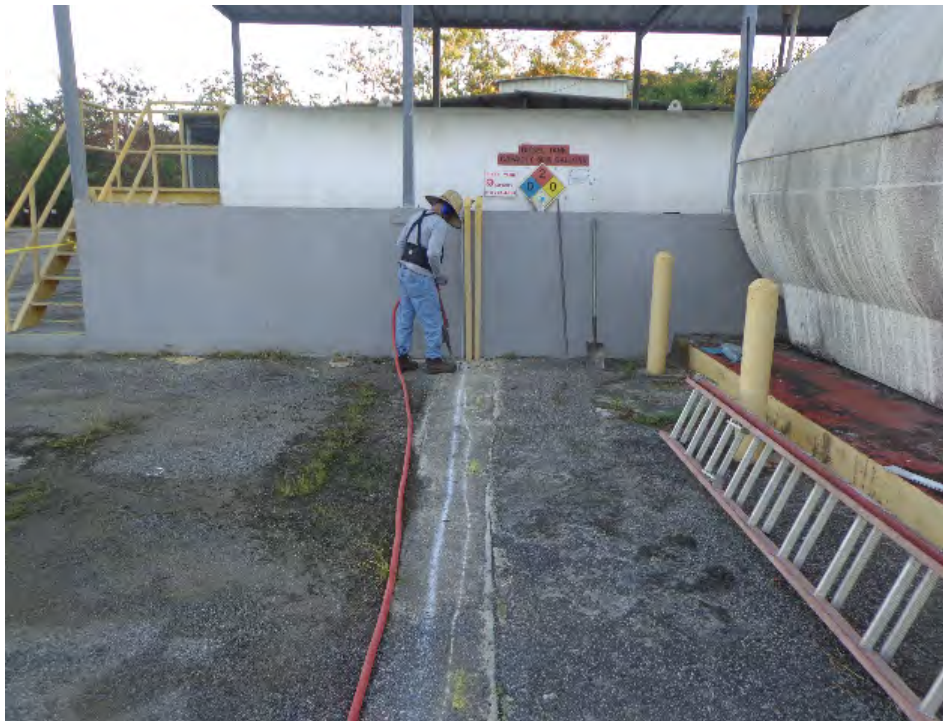
Photograph: 10

Description: Demolition of concrete layer on top of pipelines using pneumatic chipping hammer.

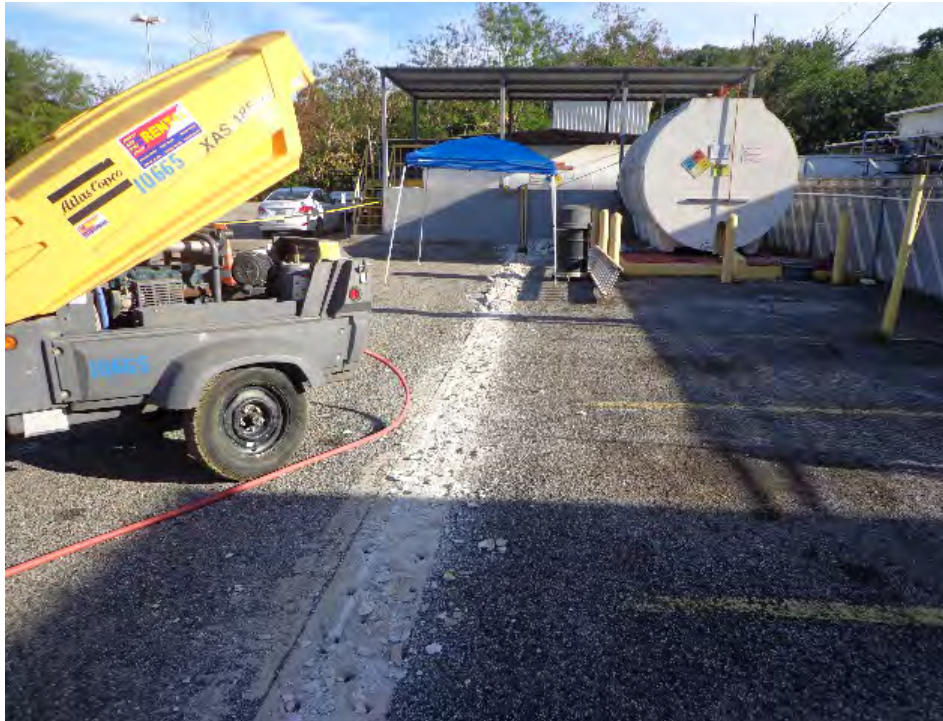
Photograph: 11

Description: Demolition of concrete layer on top of pipelines using pneumatic chipping hammer.

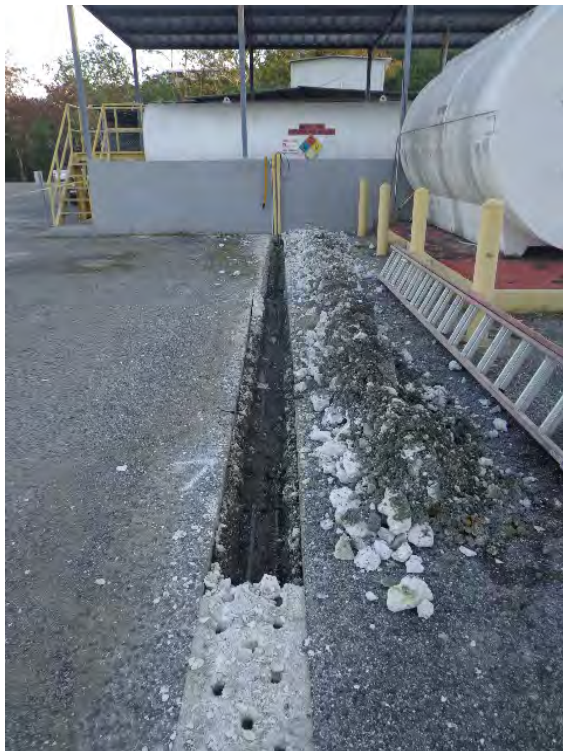
Photograph: 12

Description: Discovery of pipelines beneath concrete slab.

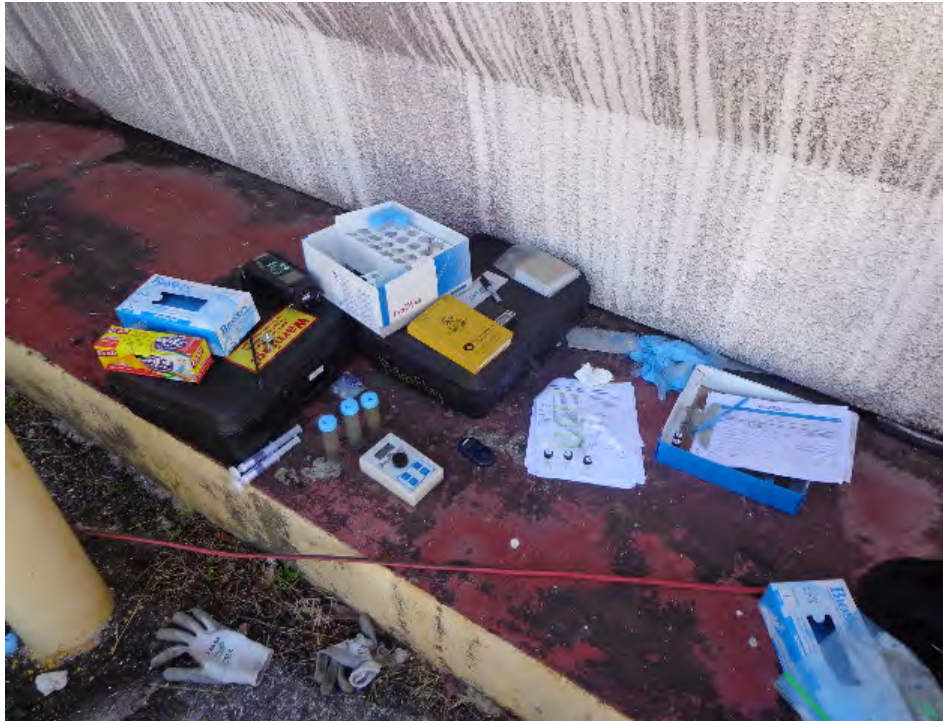
Photograph: 13

Description: View of PetroFLAG® field screening kit used to screen soil after removal of pipeline.

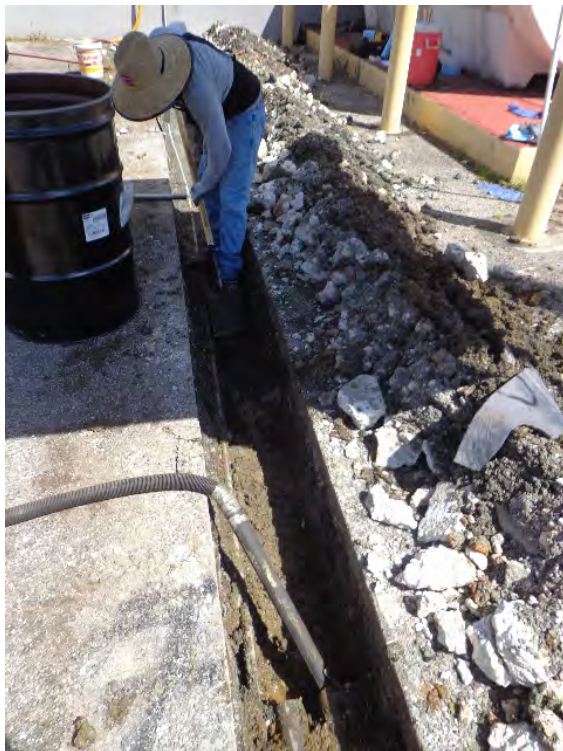
Photograph: 14

Description: Removal of impacted soil from bottom of trench/excavation after removal of pipelines.

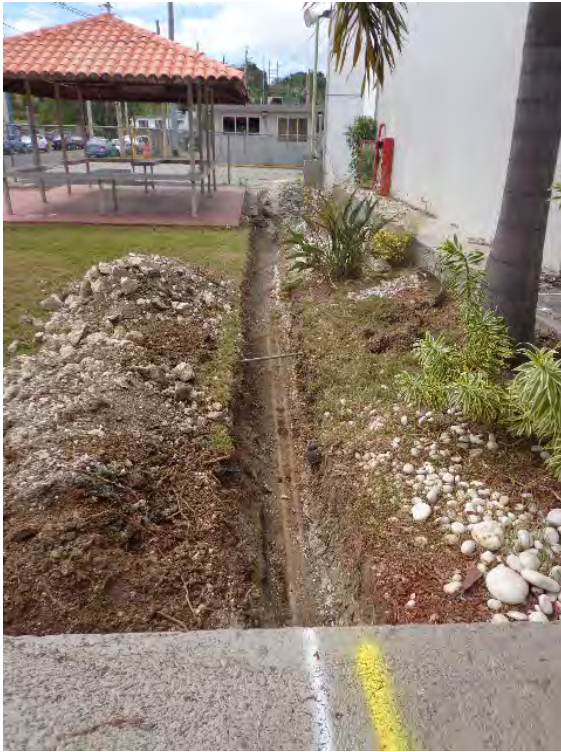
Photograph: 15

Description: View of underground pipelines after removal of top soil.

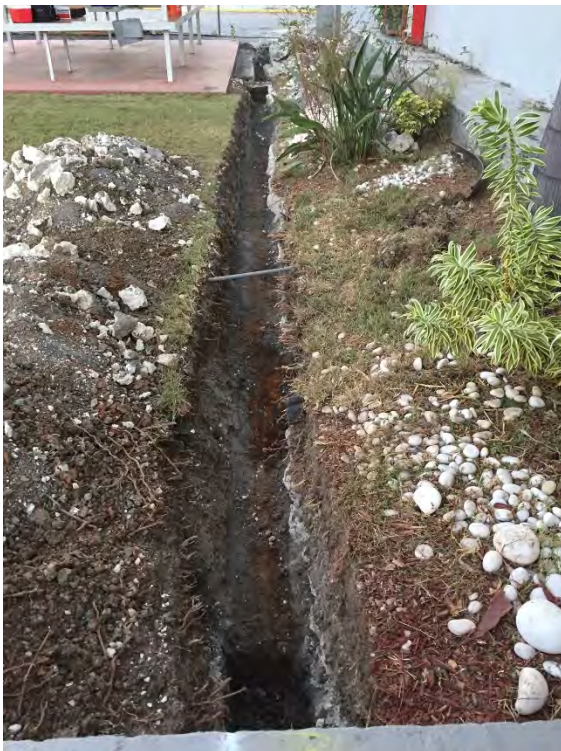
Photograph: 16

Description: View of bottom of trench/excavation after removal of underground pipelines.

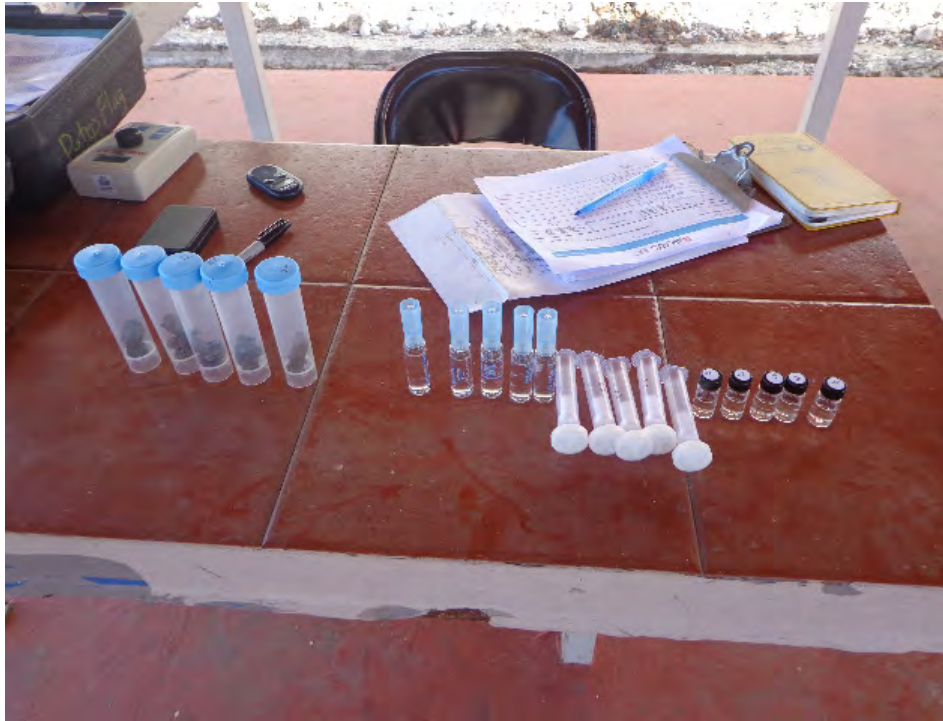
Photograph: 17

Description: View of PetroFLAG® field screening kit used to screen soil after removal of pipeline.

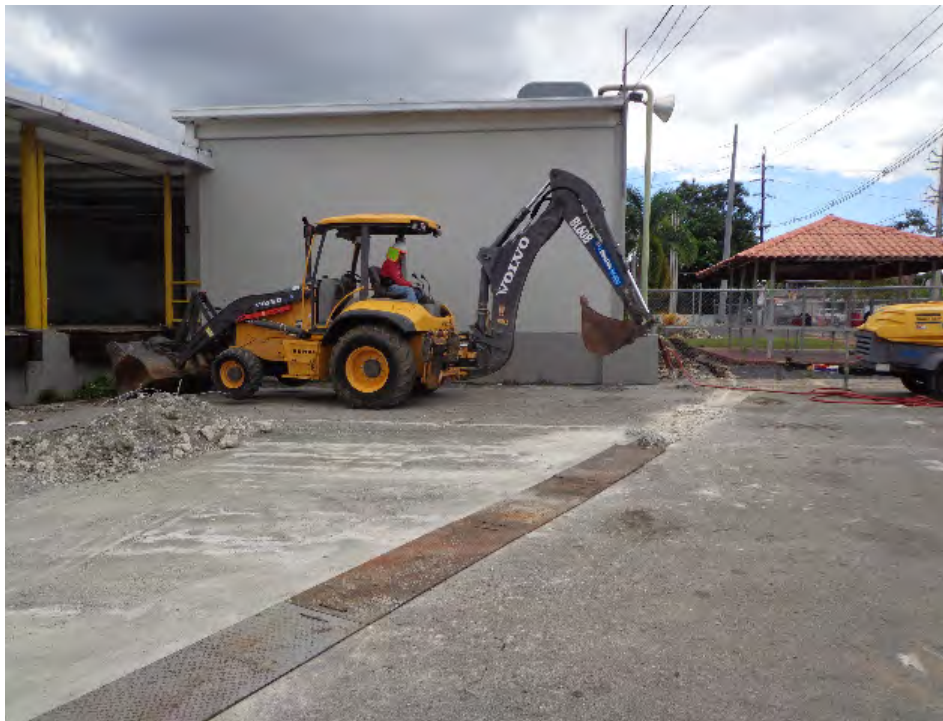
Photograph: 18

Description: View of backhoe used for removal of soil after pipeline removal.

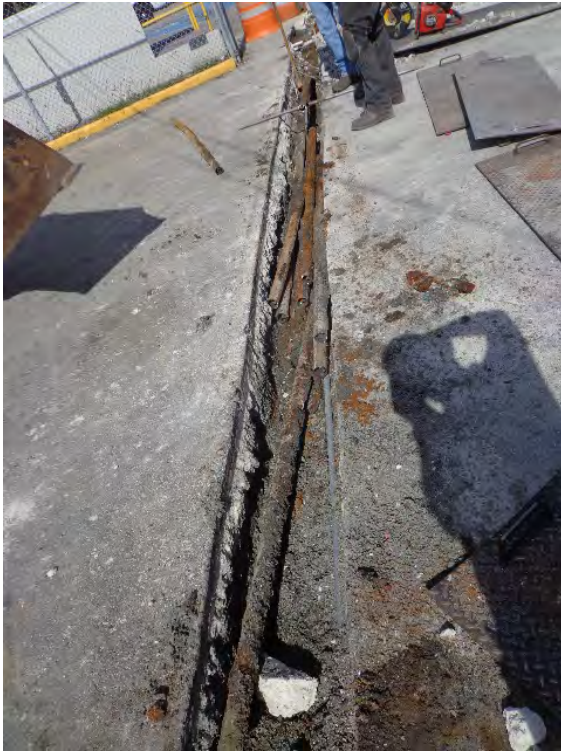
Photograph: 19

Description: View of pipelines cut into pieces prior to removal.

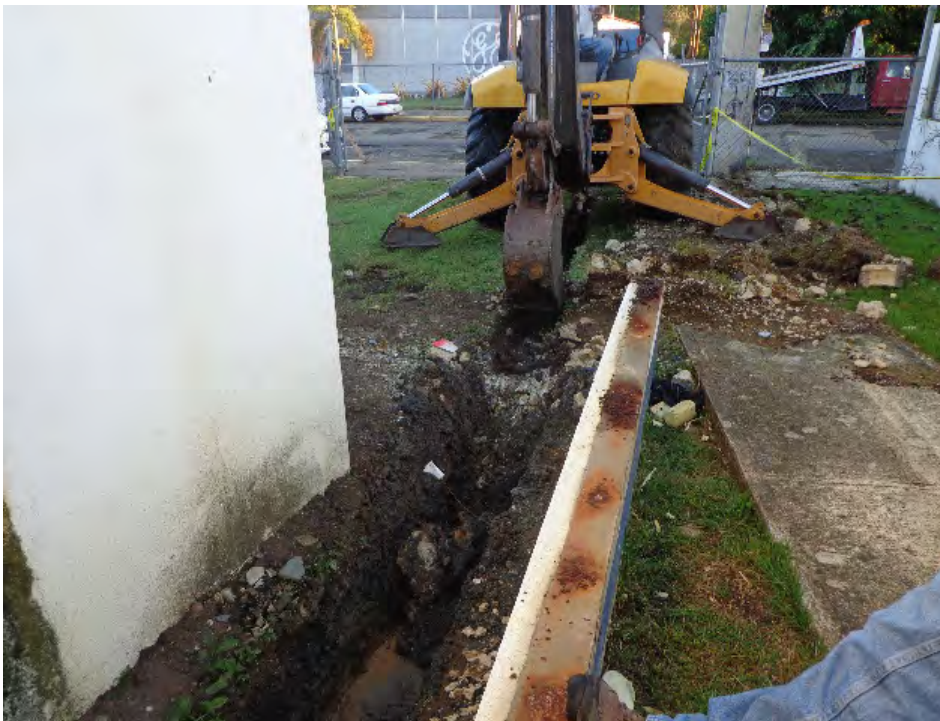
Photograph: 20

Description: Removal of impacted soil using backhoe.

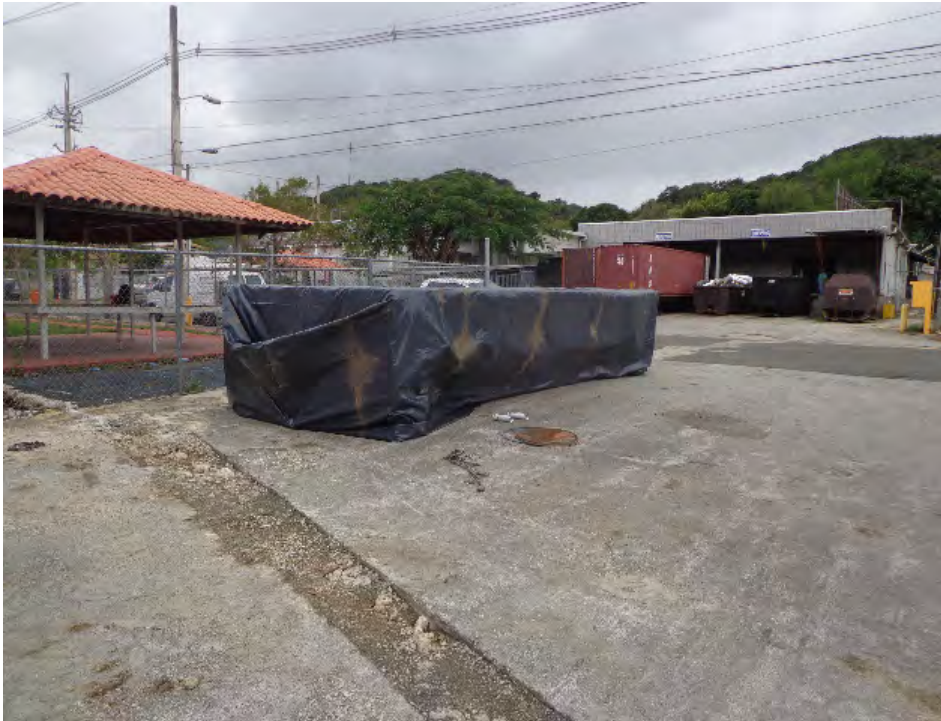
Photograph: 21

Description: View of roll-off container for temporary storage of impacted soil removed from excavation/trench.

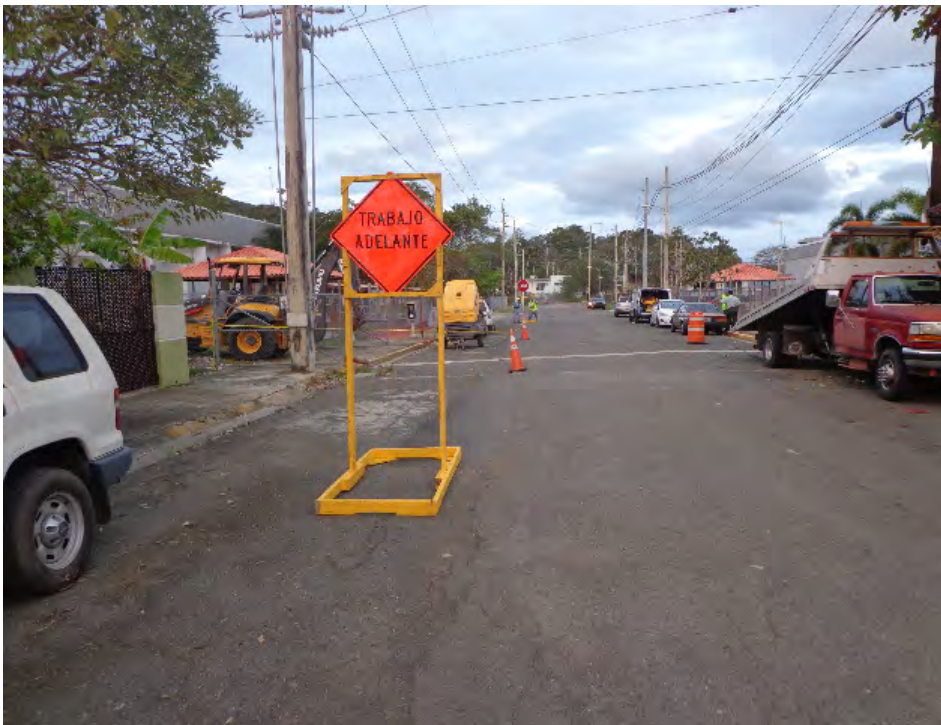
Photograph: 22

Description: Beginning removal activities. Note signs and cones.

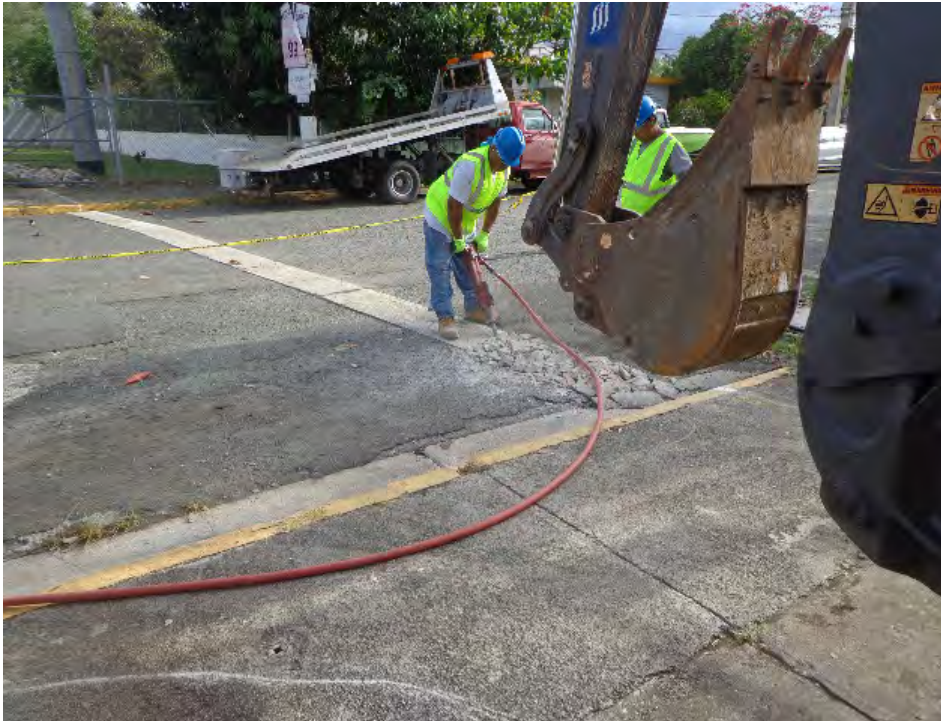
Photograph: 23

Description: Demolition of concrete layer on top of pipelines using pneumatic chipping hammer.

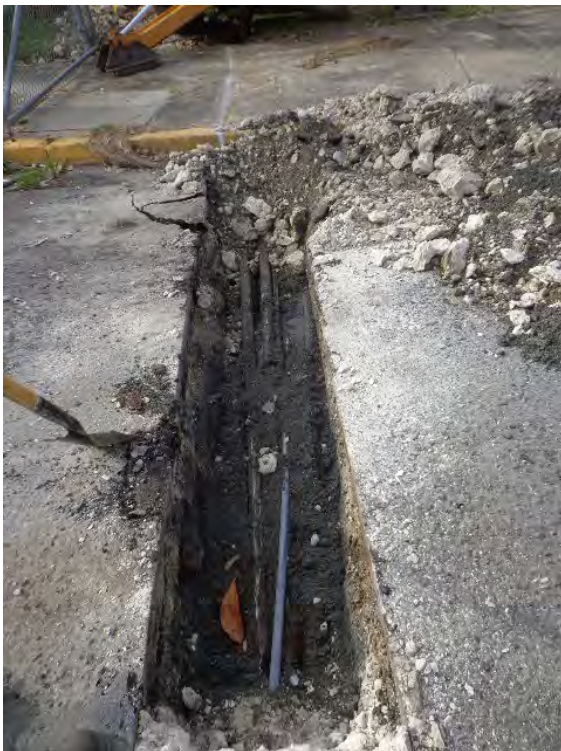
Photograph: 24

Description: Discovery of pipelines after concrete slab removal

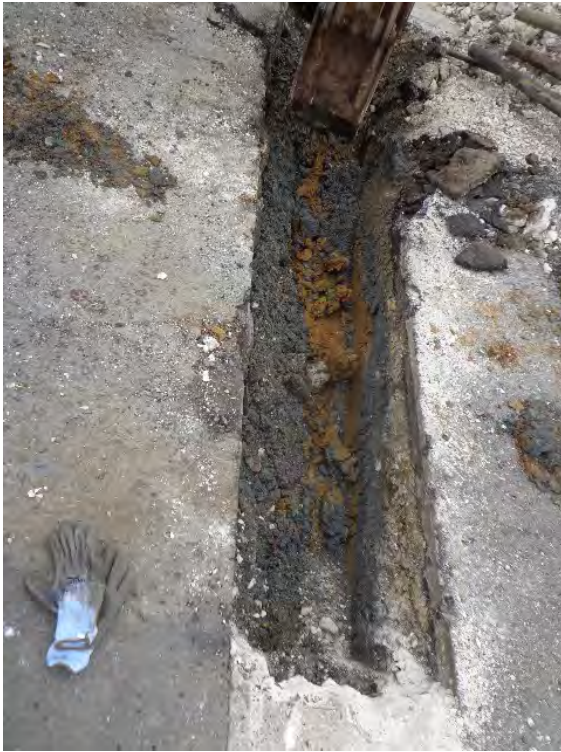
Photograph: 25

Description: Removal of impacted soil with backhoe after removal of pipelines

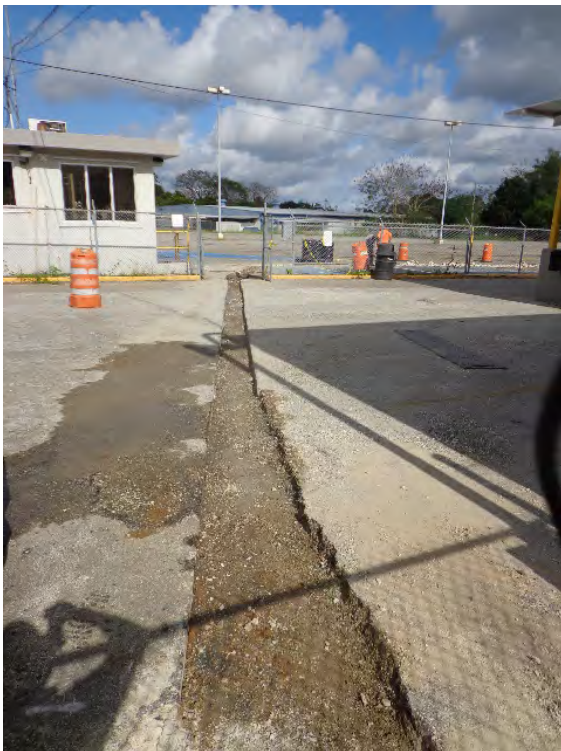
Photograph: 26

Description: Backfilled trench/excavation after soil sample result showed TPH-DRO concentration <100 mg/kg.

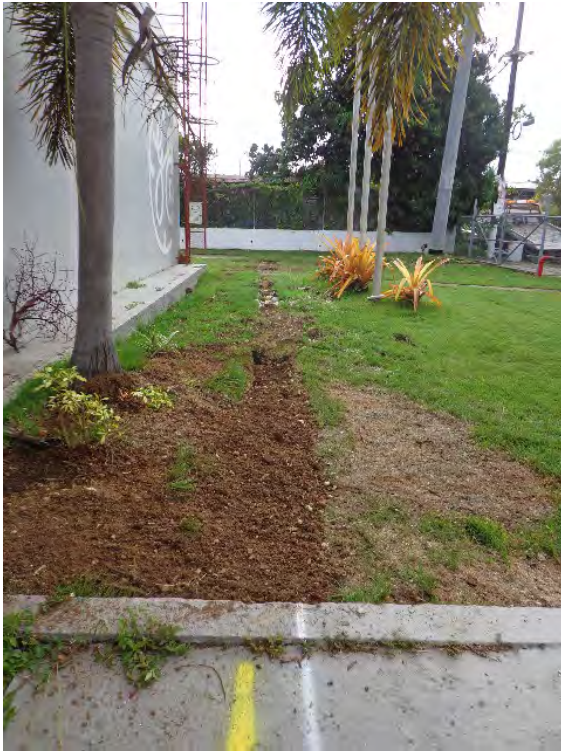
Photograph: 27

Description: Backfilled trench/excavation after soil sample result showed TPH-DRO concentration <100 mg/kg.

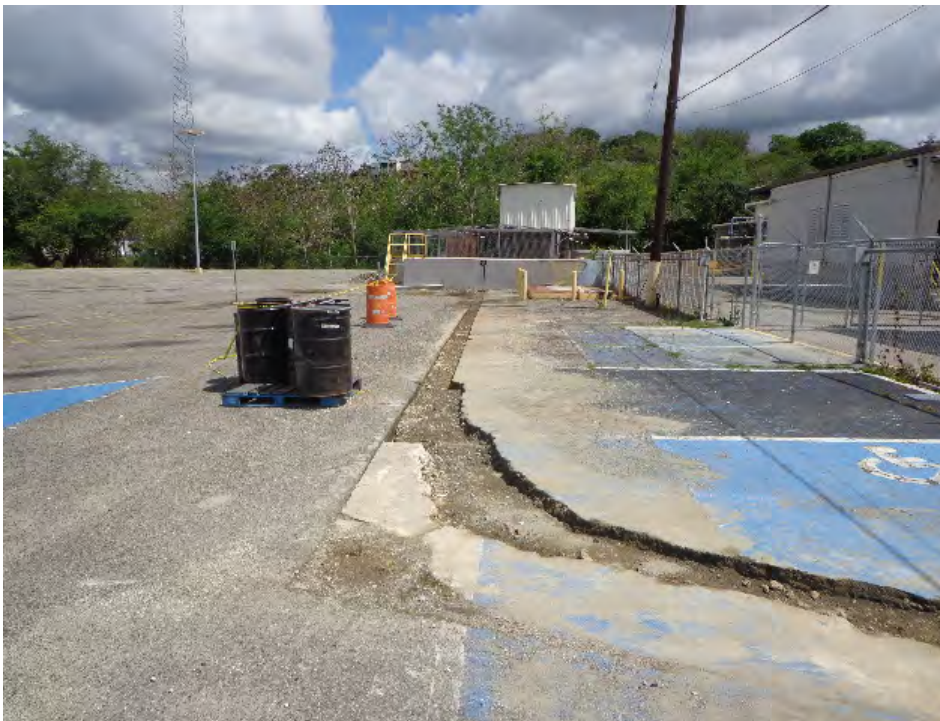
Photograph: 28

Description: Backfilled trench/excavation after soil sample result showed TPH-DRO concentration <100 mg/kg.
